Results and Recommendations of Forensic Investigation of Three Full-Scale GRS Abutment and Piers in Denver, Colorado

June 2001

**COLORADO DEPARTMENT OF TRANSPORTATION
RESEARCH BRANCH**

1. Report No. CDOT-DTD-R-2001-6	2. Government Accession No.	3. Recipient's Catalog No.	
4. Title and Subtitle Results and Recommendations of Forensic Investigation of Three Full-Scale GRS Abutment and Piers in Denver, Colorado		5. Report Date June, 2001

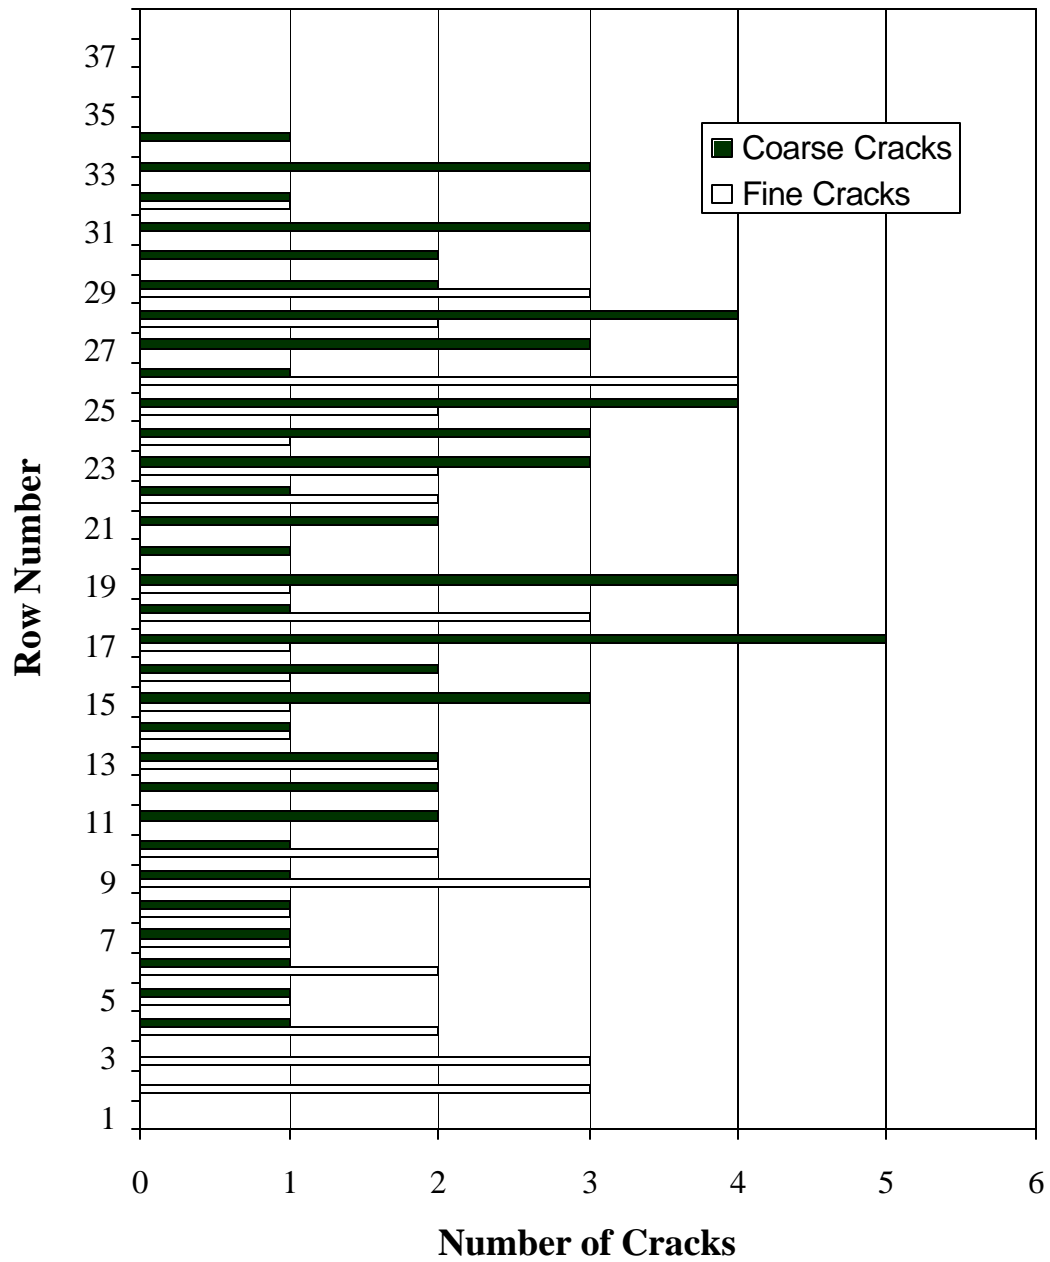
Figure 6 Density of Cracking along the East Face of the Outer Pier

Different types of blocks were used in the construction of the three Havana Yard Structures (Figures 3 to 5). There were few cracks visible in the external face of the abutment before the dismantling began, but during dismantling, a fairly large percentage – as high as 50% – of the blocks in some layers was broken. On most of the levels, most of the broken blocks were on the side where the surcharge load was applied (Figure 1). There were no visible cracks in the external face of the center pier (the pier that was not surcharge loaded) and no internally broken blocks were found during the dismantling operations. The facing of the outer pier (see Photo 5 and 6) was severely damaged, as was observed in the cracking of the external face (Figure 6) and

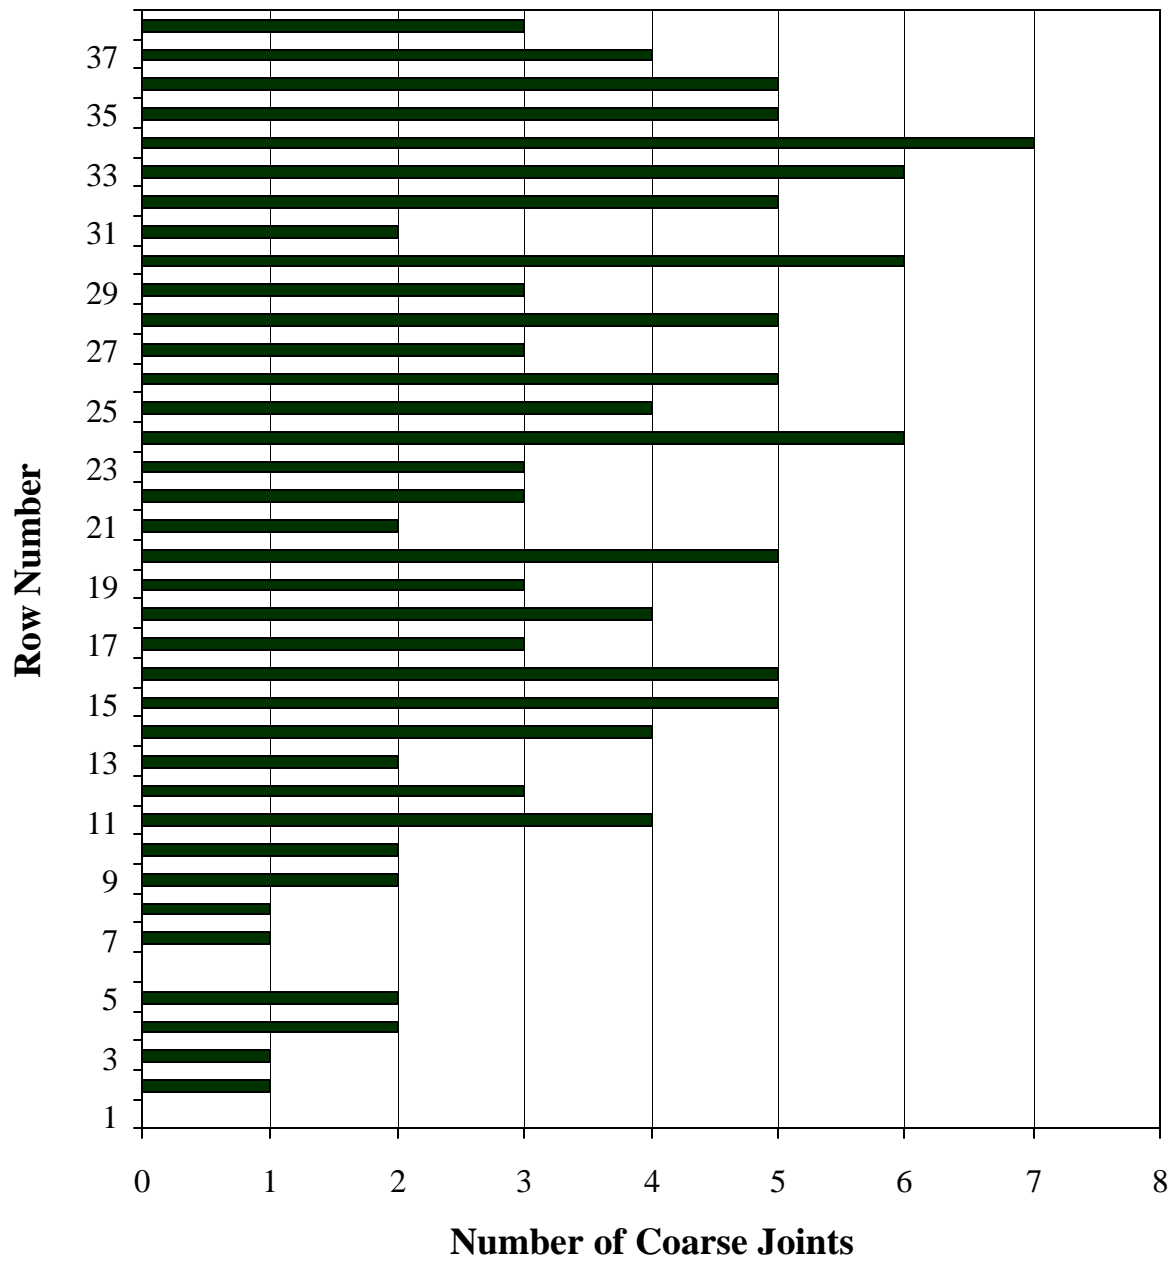
Figure 7 Density of Opened Joints along the East Face of the Outer Pier Indicating Movement Parallel to the Facing

broken internal sides of the blocks (Figures 11 to 13). The facing of the outer pier experienced excessive movements, especially the upper four layers. This movement decreased with the depth from the top of the pier (Figures 7 to 10). Additional descriptions of the movement and damage of the pier and possible causes for this response are provided in the next section.

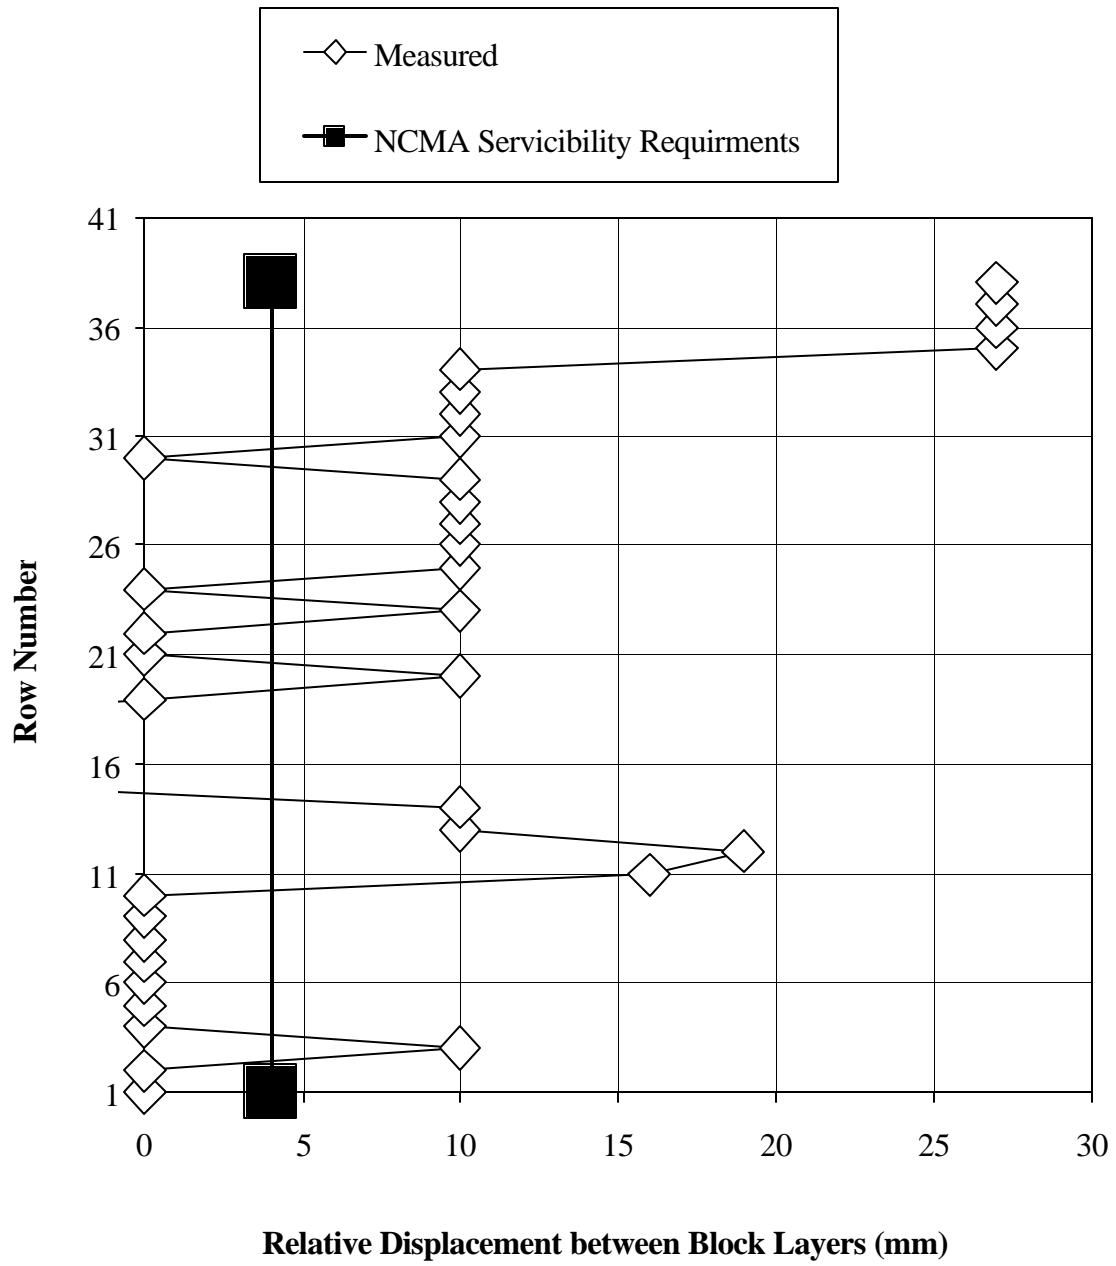
Figure 10 Measured and Maximum Recommended Relative Outward Displacements between Block Layers

facing connection capacity is not developed at the expense of unacceptable wall movement. A relative displacement between block layers below 2% of the height of the block (4 mm in our case) is recommended by NCMA guidelines to insure that serviceability block-to-block connection (or interface shear) capacity criterion is met (Bathurst and Simac, 1997). Results of Figure 10 indicate this criterion was not met for the upper 14 block layers (rows 25 to 38). In the Havana Yard outer pier structure, a fabric layer was placed between block layers and the hollow concrete blocks were filled with uniform size gravel. This facing system developed its block-to-block connection capacity by interface friction between blocks and reinforcements and between gravel and reinforcements. That is, no interlock with shear key or other form of mechanical or positive connection was used.

Both the results of forensic investigation (Figure 10) and facing connection stability analysis (Table 5) indicated that layers 25 to 38 of the outer pier failed to meet the serviceability block-to-block connection requirements (i.e., relative displacement between block layers larger than 4 mm). If higher soil friction angles of 36 and 40 degrees were employed in the analysis, the connection capacity would still be exceeded for block layers above 27 and 29, respectively. This indicates that serviceability connection capacity would have been exceeded in the upper zone of the outer pier structure even if the backfill had been well compacted. Therefore, some form of positive block-to-block mechanical connection was needed for a geosynthetic-reinforced soil structure supporting a high surcharge load.

- ❑ In the top 1.6 m of piers loaded with a high surcharge load, it is recommended to: 1) place reinforcements with a wrapped-around procedure behind the facing, and 2) employ mechanical connection between blocks and between blocks and reinforcements. Results of this research and other studies suggest that the friction-based facing connection strength in the lower zone of the pier is adequate.

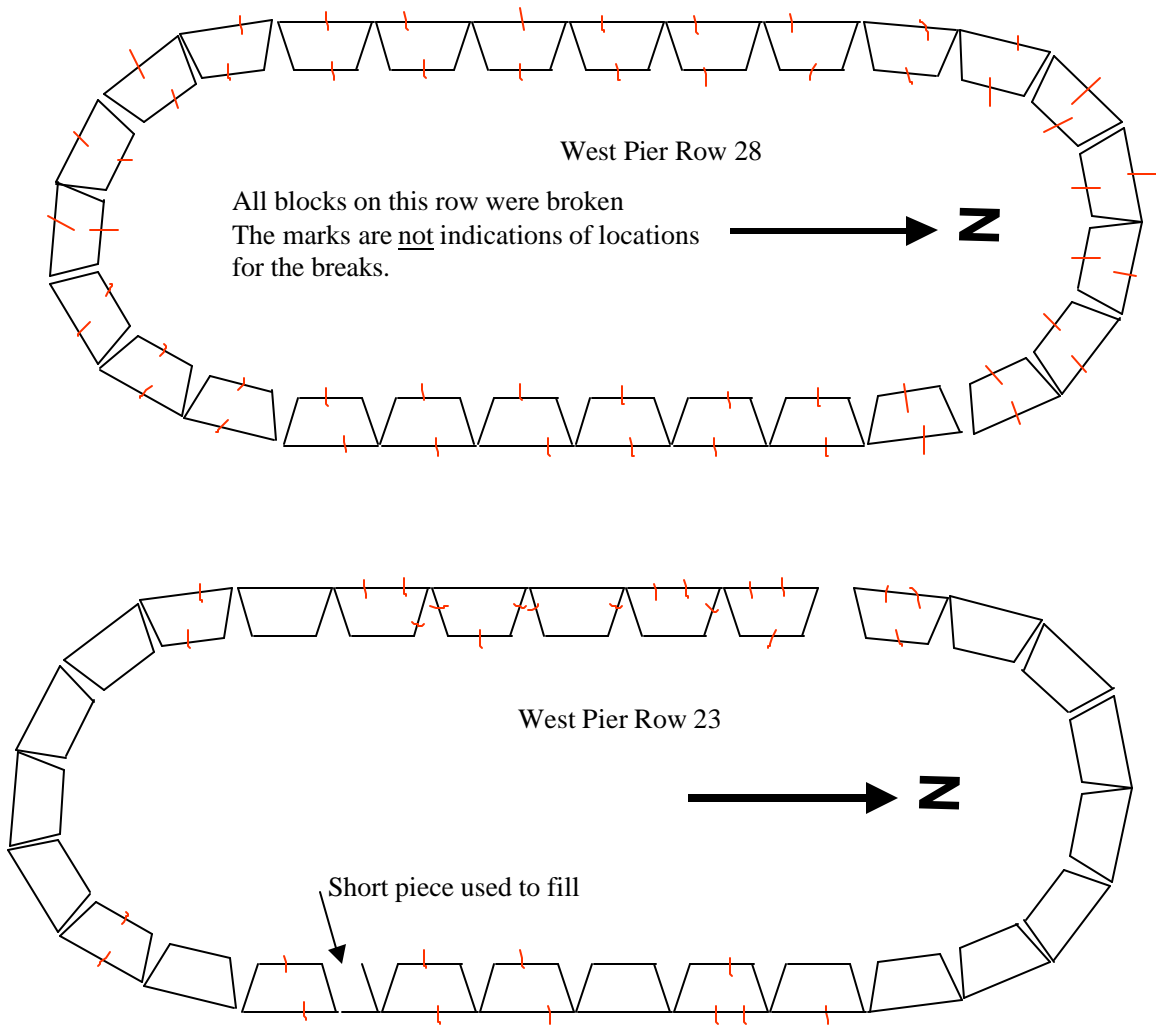
Figure 11 Mapping Results for the Blocks' Breaks in the Upper Zone of the Outer Pier
(Note: Marks indicate the broken sides, not location of the breaks)

No damage was noticed for the internal sides of the upper four block layers (rows 35 to 38), but all other layers had broken blocks. In rows 33 and 34, the blocks were broken into several pieces. As the dismantling progressed, it became apparent that many of the blocks that appeared from the outside to be whole were also broken. Typical mapping results for the blocks' breaks at different levels in the pier structure are shown in Figures 11, 12, and 13. Note that the marks indicate the broken sides, not exact location of the breaks. From layer 32 down to 30 all of the blocks were broken (~ 27 blocks per layer). In rows 29 through 27 there were only five unbroken blocks. On row 27, all blocks were broken, on row 26 there were two unbroken blocks, on row 25 there were 7 unbroken blocks, and on row 24 there were 5 unbroken blocks. For the entire pier, more blocks on the straight sides of a given layer were broken than in the curves at the ends of the layer (Figure 11 to 13). Most of the unbroken blocks were either on the curves or at the end of the straight sides of the pier (see Figures 11 to 13). From rows 32 to 24, there were almost no unbroken blocks in the straight part of the pier. It is also clear from the mapping results that the lower layers had more unbroken blocks. The breaks in all of the blocks were nearly vertical from the top to the bottom of the block; no intersection of one break with another was observed. Most broken blocks had at least two breaks. Most blocks had only one break per side and most breaks were near a corner, although multiple breaks in a side and breaks near the centers of the faces were found. While many of the blocks were broken in several places, none was shattered.

- ❑ Upper zone of block layers 35 to 38: No cracking to the external facing, or internal damage to the blocks was noticed in this zone. The upper four layers experienced excessive relative outward displacement between block layers and significant opening of vertical joints.
- ❑ Middle zone of block layers 11 to 34: This zone moved to a lesser degree than the upper zone but was the most heavily damaged and cracked. The relative displacements of block layers 25 through 34 were approximately 10 mm. On the average, smaller relative displacements were noticed for layers 11 to 25 (movement decreased with depth).
- ❑ Lower zone of block layers 1 to 10: In this zone, the intensity of block damage (cracking and breaks) diminished and the facing experienced negligible movement.

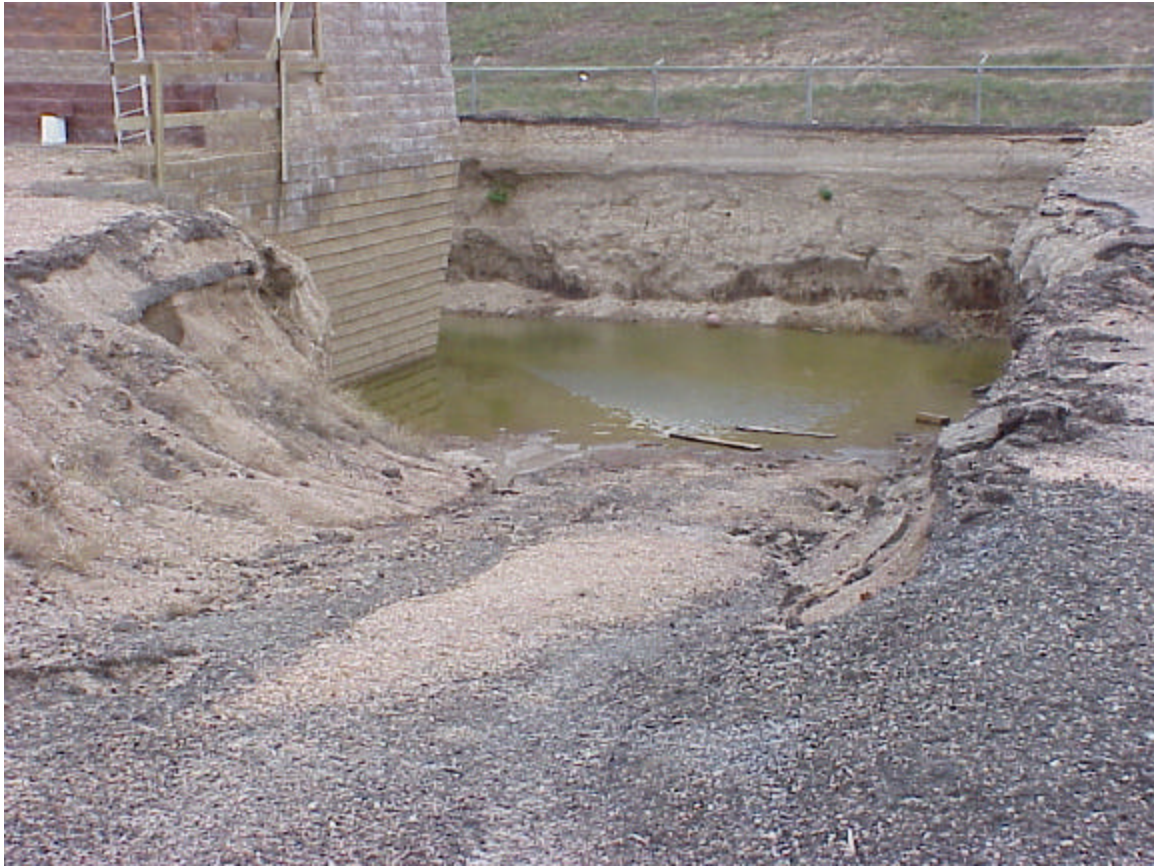
Photo 3. Lower Portion of the Abutment Structure. Note the negative batter. This was done only on the east side of the abutment and only below the ground level.

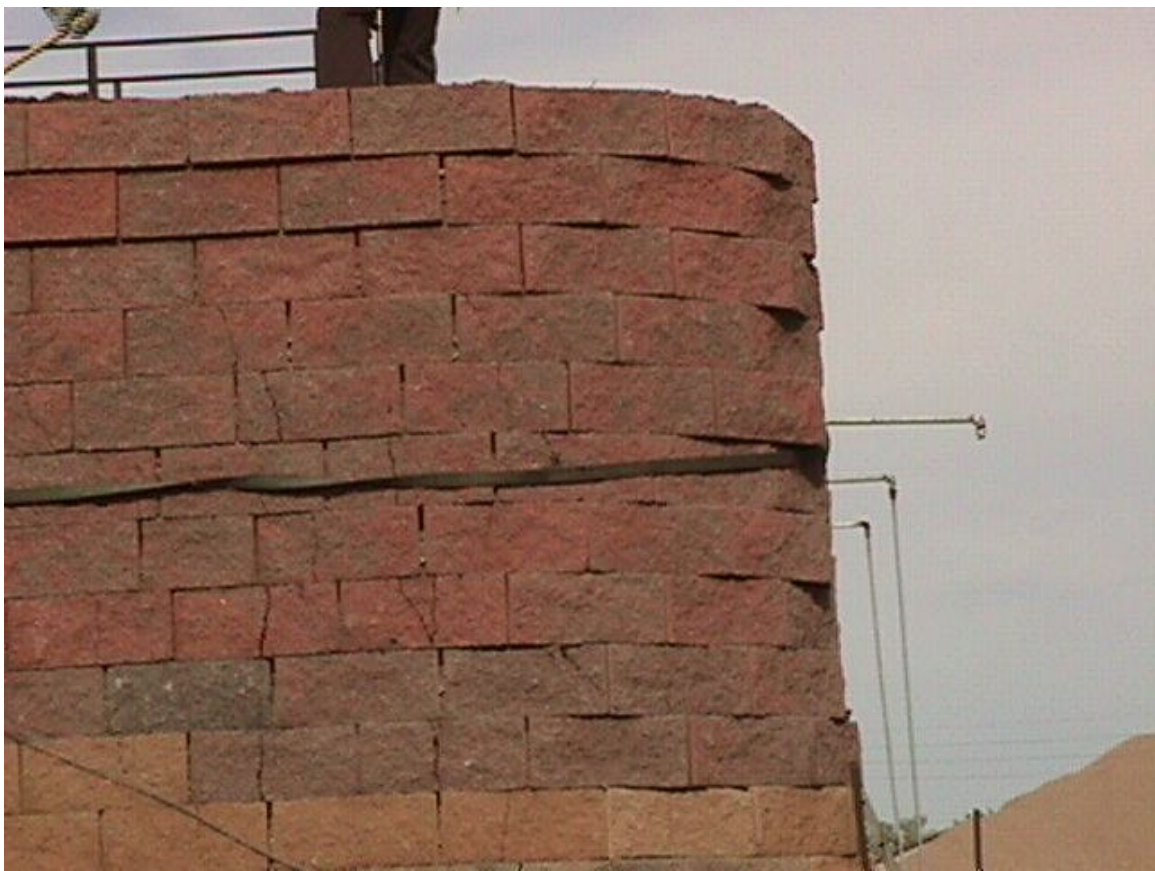
Since the blocks of the outer pier structure were severely cracked and the upper four rows showed significant movements (see Photos 5, 6 and 7), the external and internal conditions of blocks were thoroughly examined. The results of this examination are presented in the following subsections.

Photo 6. Excessive Movements of the Top Rows of Blocks on the Outer Pier.

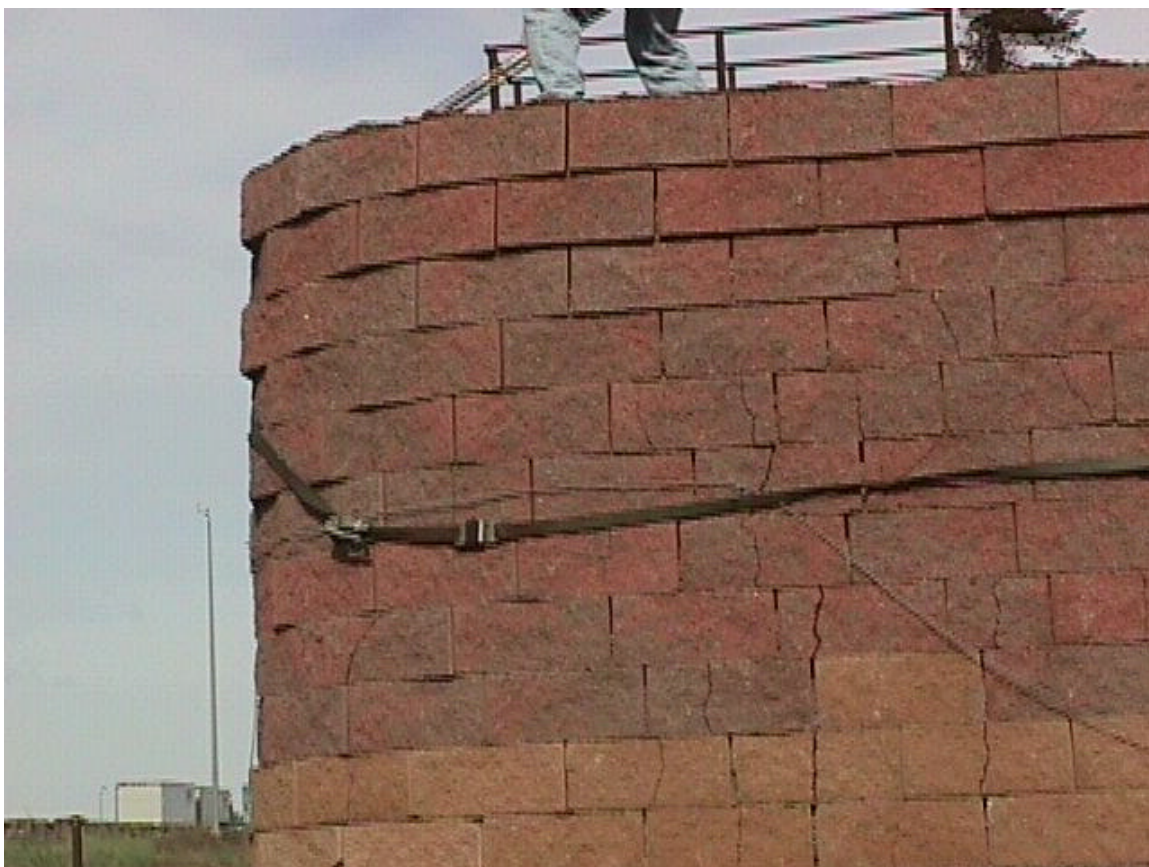
Photo 7. Excessive Cracking of the Facing of the Outer Pier Note that all cracks are vertical and they are aligned with joints in layers below or above the cracked blocks.

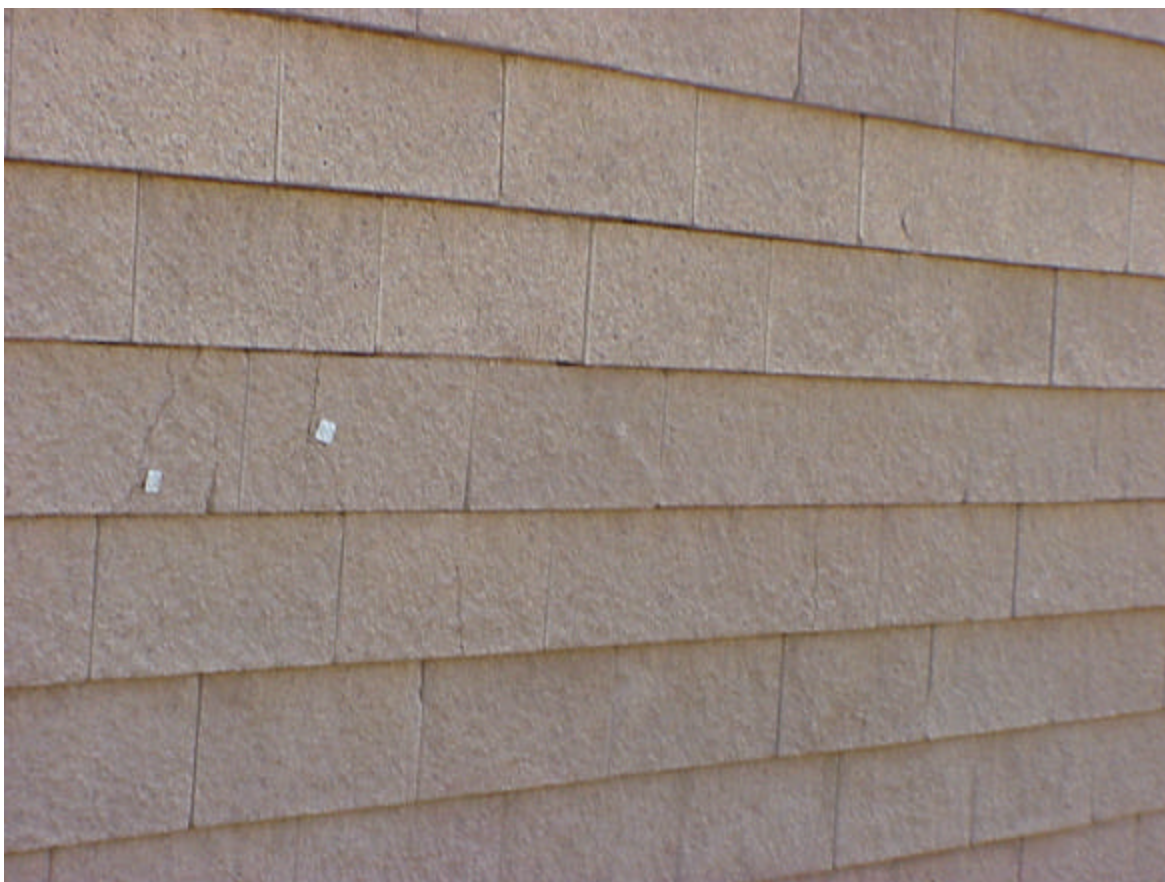
Photo 8. Cracks in the Lower Part of the Abutment.

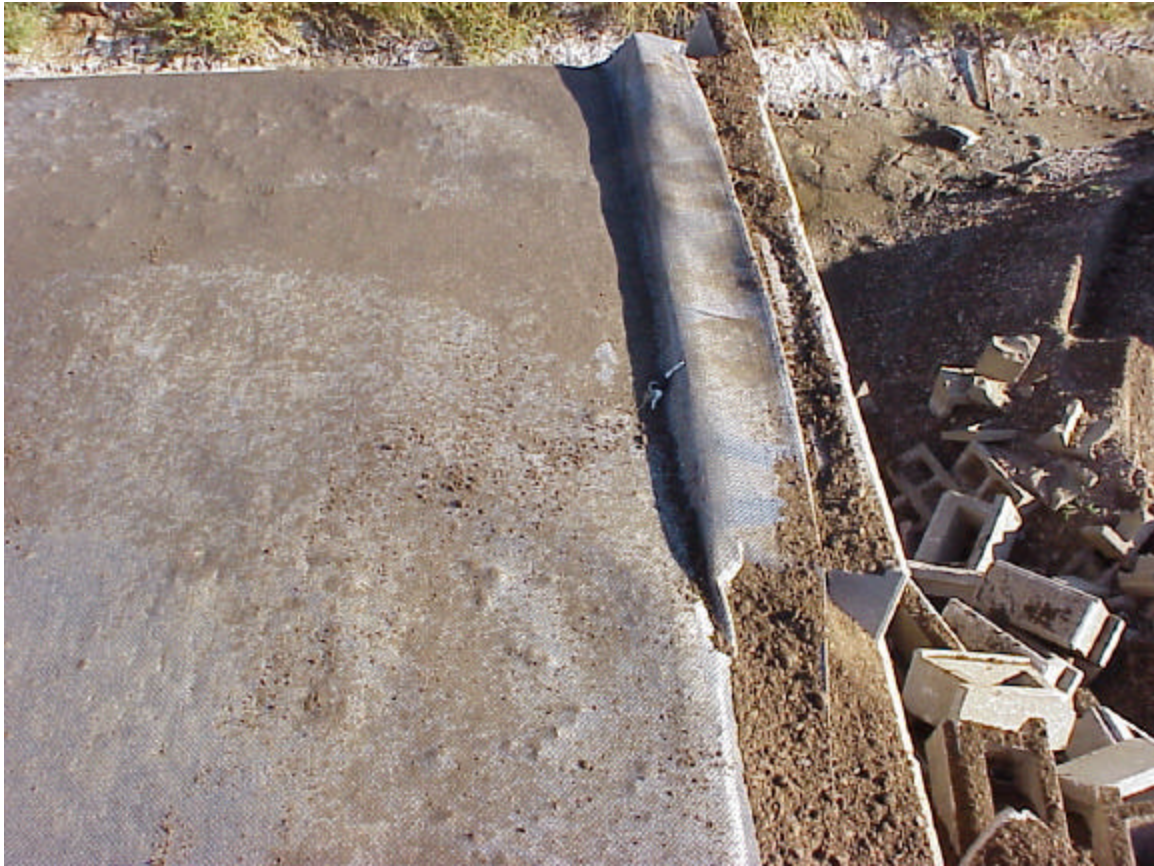
Photo 11. Geotextile Sheet During Dismantling of the Inner Pier. No damage to any of the fabric sheets was observed in any of the structures even at locations where the fill had settled considerably.
